WISCONSIN HIGHWAY RESEARCH PROGRAM

PROJECT NO. 0092-01-06

**REHABILITATION TECHNIQUES FOR
CONCRETE BRIDGES**

DRAFT FINAL REPORT

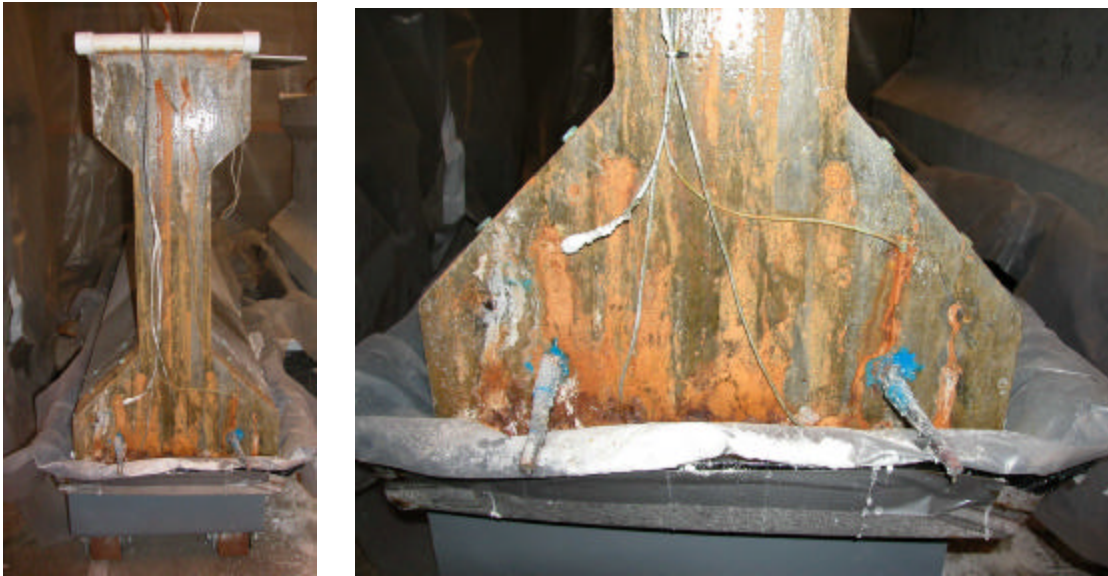
Figure 60. Beam 1: West (pre-coated) Beam-End 1A (after 6 months)

west end (1A) initially. Figure 60 illustrates the condition of 1A (pre-coated end) after 6 months of exposure. Figure 61 illustrates the condition of the southwest and northwest faces. Figure 62 illustrates the condition of the east end 1B after 6 months of exposure. Figure 63 illustrates the condition of the southeast and northeast faces.

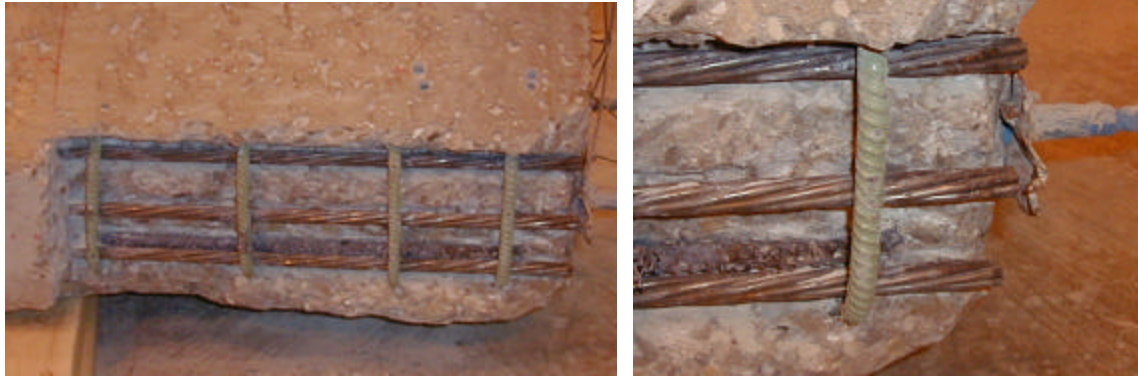
Figure 71. Beam Section Removed for Patch Repair

After 6 months of exposure, both ends were cleaned to remove salt residue and rust products from the surface of the beam. Since 6 months of exposure did not result in the spalling of concrete, an 18-inch long concrete region of the east end was removed with a chipping hammer for installation of the patch repair (see Figure 71).

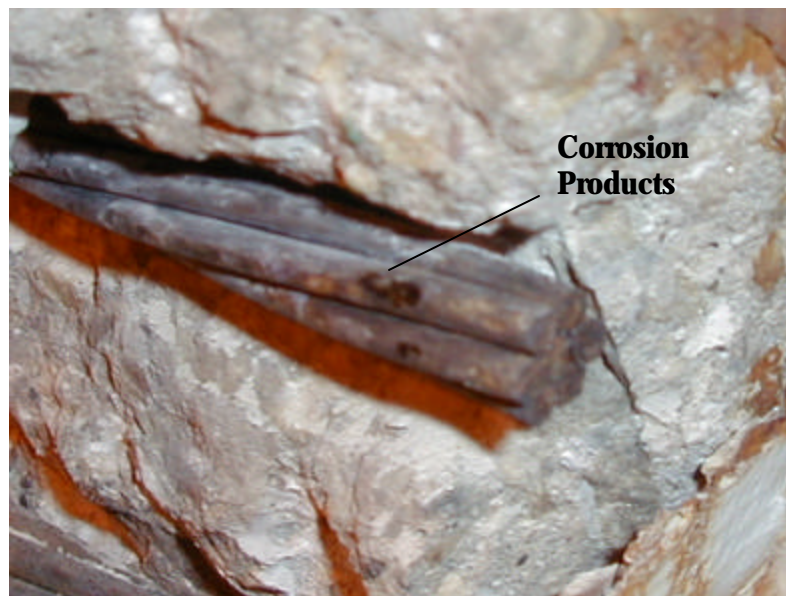
Figure 72. Close-up View of Tendon from Dissected Beam End

Figure 72 shows a close-up view of one of the strands. Corrosion products were observed mainly at the end regions of the strands. The build-up of corrosion products was seen to decrease as the distance from the edge of the end increased. The amount of corrosion was less than the researchers had expected. It was determined to change the configuration of the salt-water exposure to facilitate greater exposure on the sides of the beam to salt water.

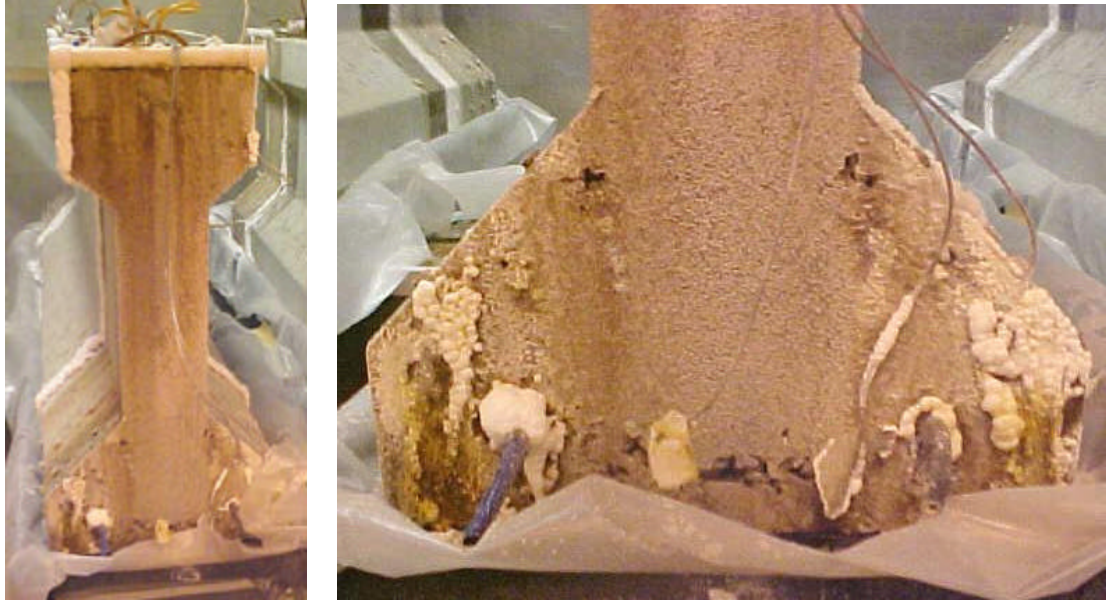
Figure 74. Beam End 2A: West End (untreated) (After 10 months)

Figure 74 illustrates the condition of the west (untreated) after 10 months of exposure. Figure 75 illustrates the condition of the southwest and northwest faces after 18 months of exposure.

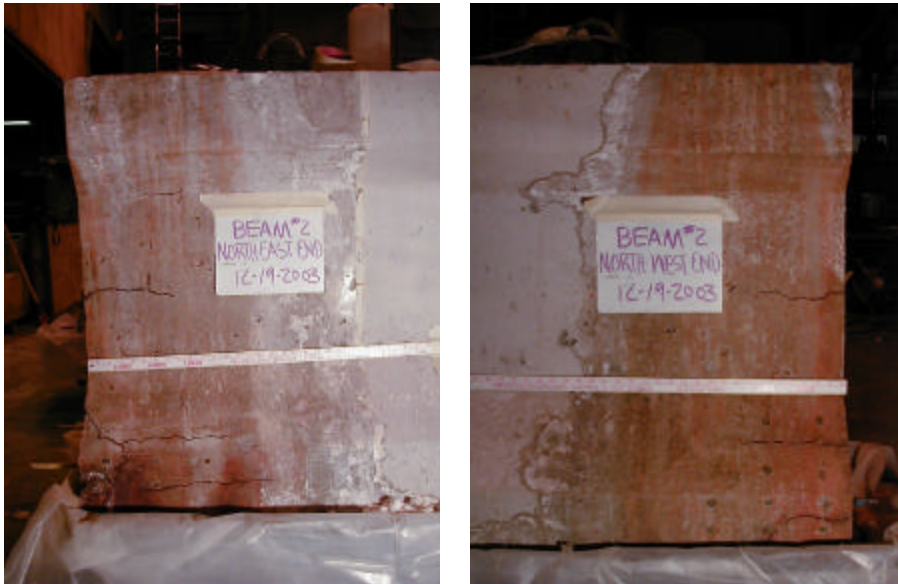
Figure 76. Beam End 2B: Southeast Face (untreated, patched) (left), Northeast Face (right) (18 months)

Figures 76 and 77 illustrate the condition of the southeast and northeast faces (patched) after 18 months of exposure.
